# THE • INTERIOR • BUILDING ITS • ARCHITECTURE • AND • ITS • ART

PRESERVATION CASE STUDIES

David W. Look, AIA  
Carole L. Perrault

U.S. Department of the Interior  
National Park Service  
Preservation Assistance Division  
1986

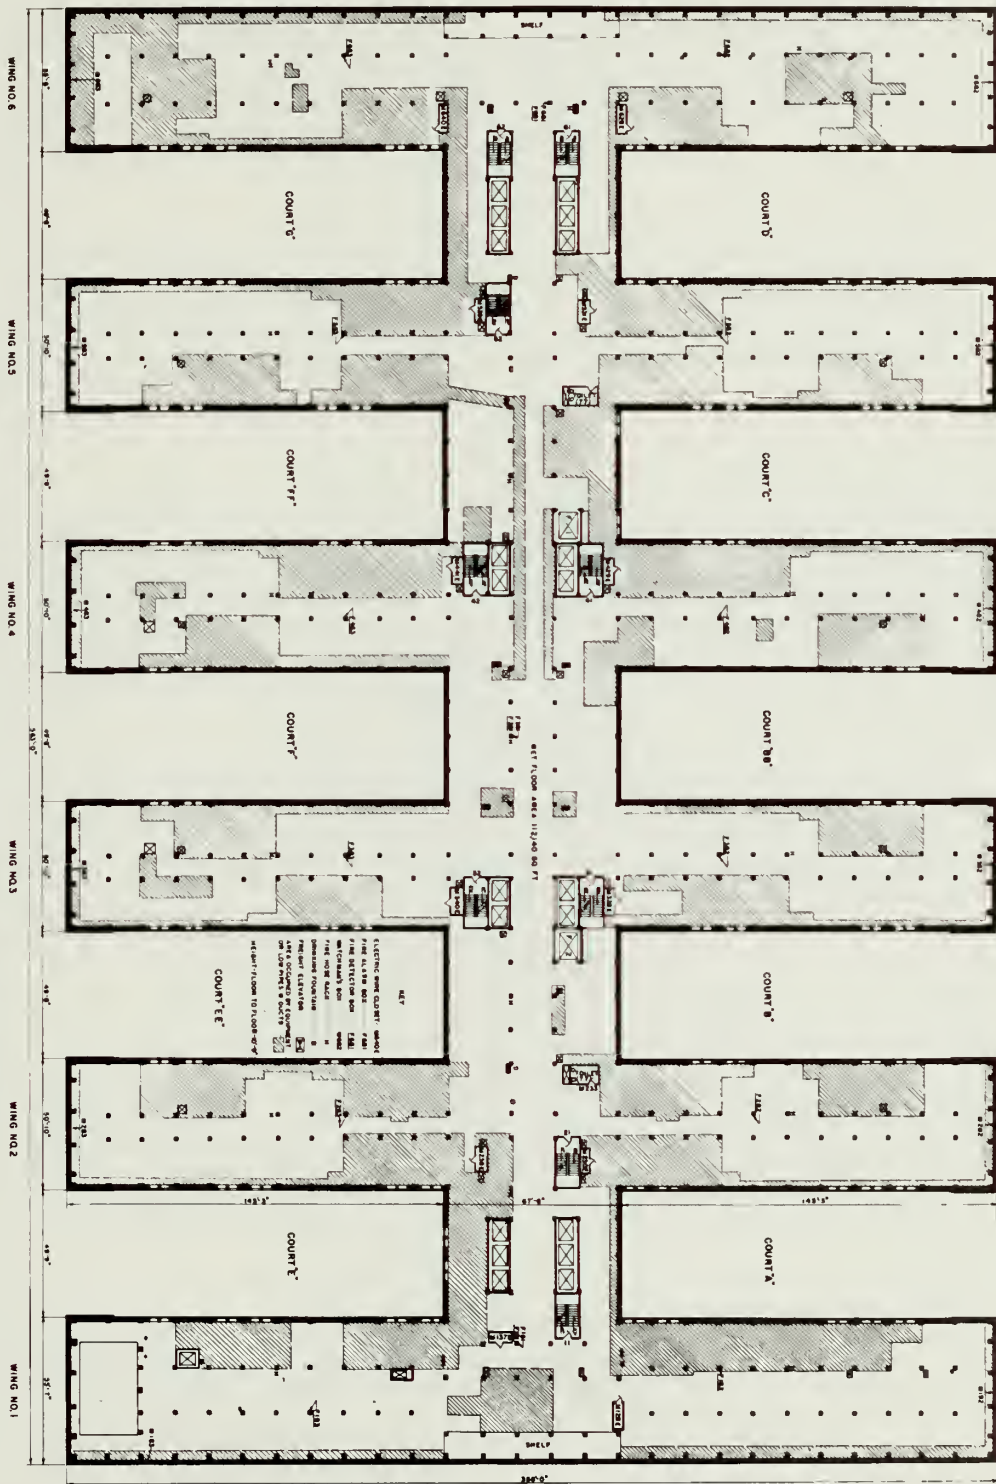
304. MECHANICAL FLOOR PLAN. Between Fifth and Sixth Floors. Revised by Federal Works Agency, 1947. Document stored at the National Record Center, Suitland,

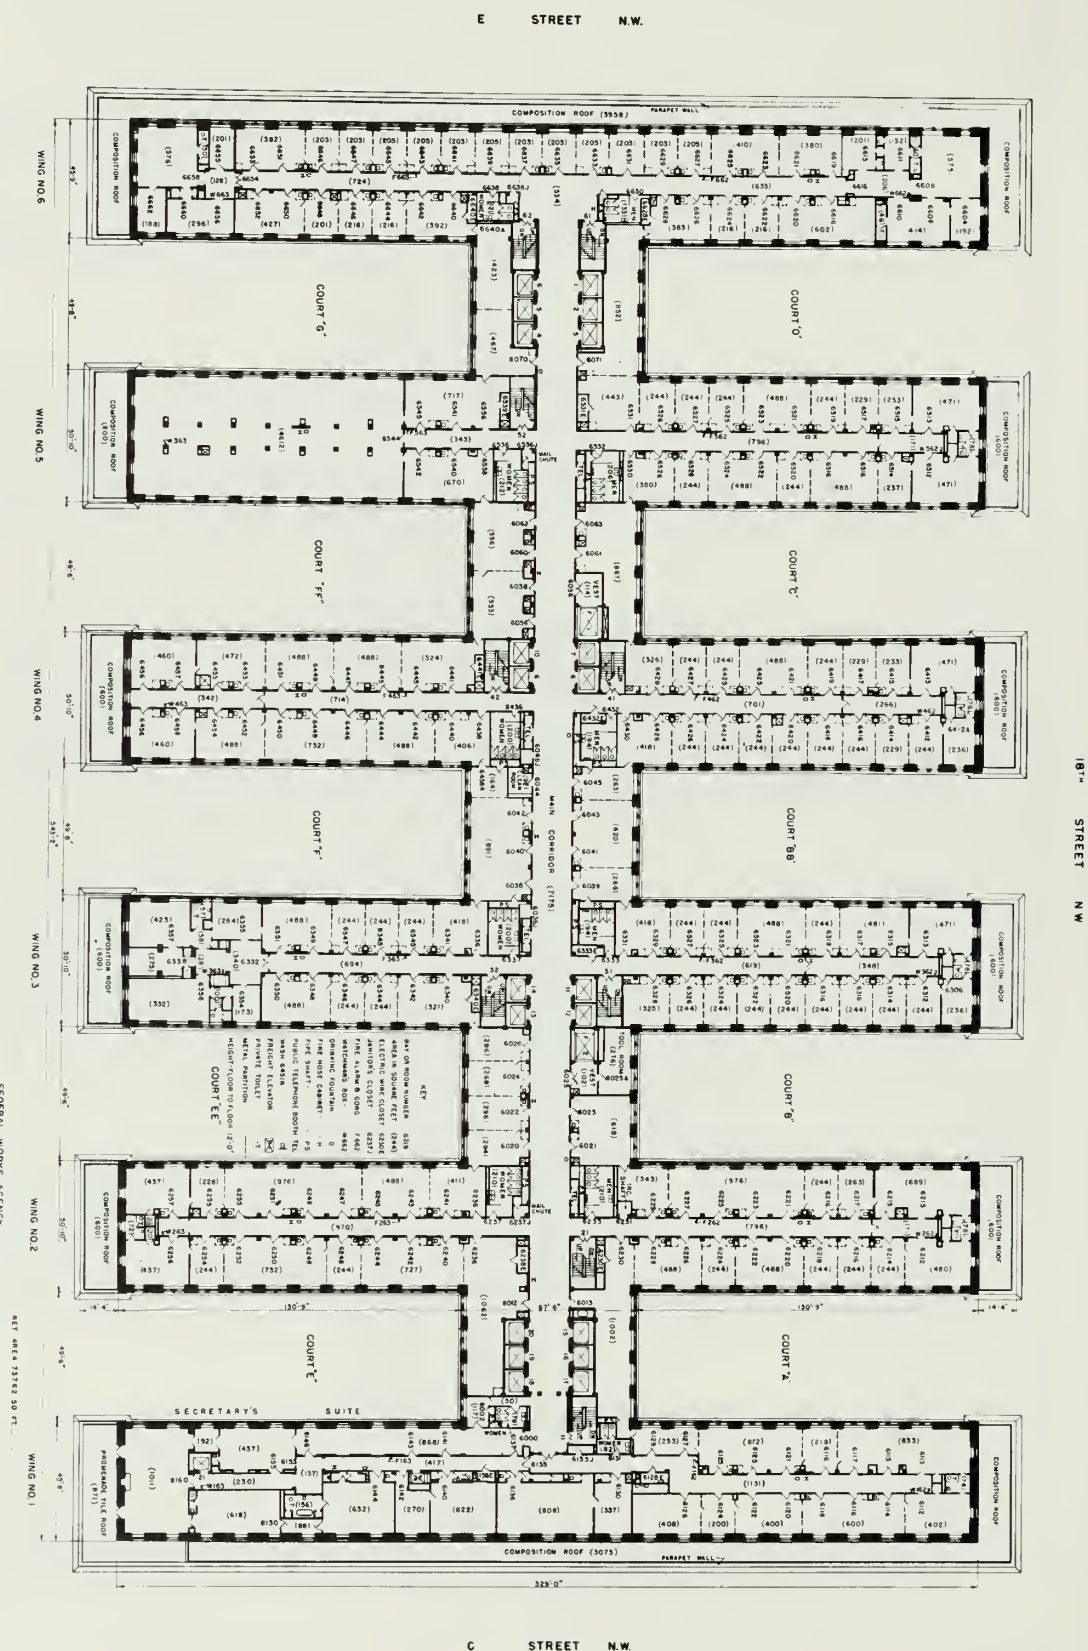
305. SIXTH FLOOR PLAN. Revised by Federal Works Agency, 1947. Document stored at the National Record

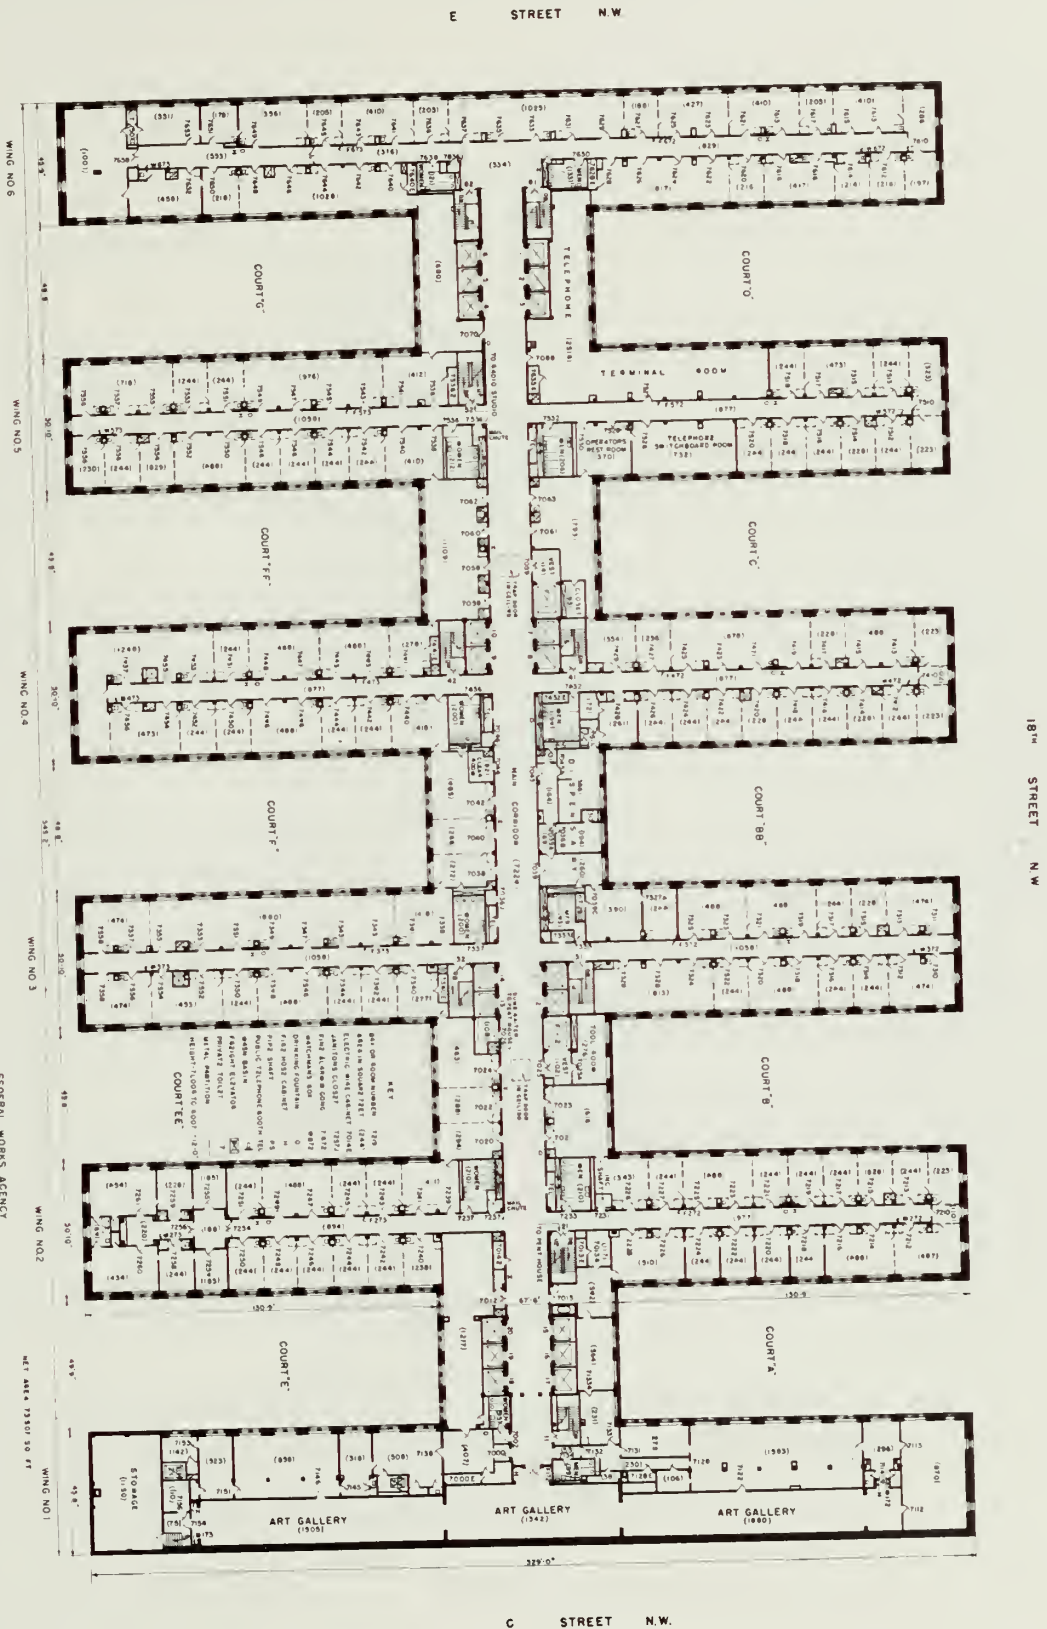
306. SEVENTH FLOOR PLAN. Revised by Federal Works Agency, 1947. Document stored at the National
